Thermography for Optimisation of Installed Wind Turbines

Deutsche WindGuard Engineering GmbH

InfraTec solution:

ImageIR® 8300

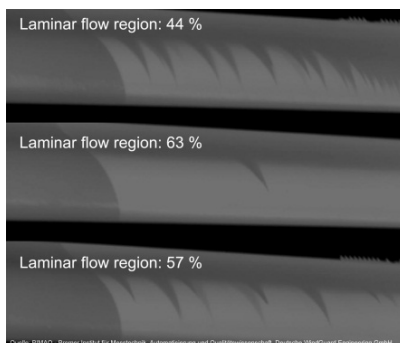
In addition, there are many more factors that negatively affect the efficiency of wind power stations. It starts with alignment of the blades, leading edge contamination, erosion and damages to defective flow control add-ons, such as leading edge protection, vortex generators and zig-zag tape sections.

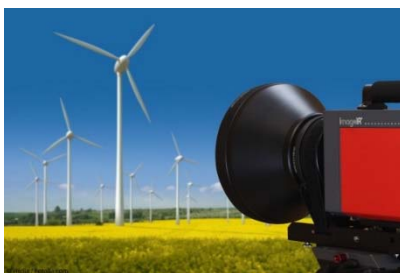
For several years now, thermography has been a valuable tool for investigating the boundary layer behavior on airfoils in order to aerodynamically optimise it. It makes use of the fact that the heat transfer resistance of the boundary layer is significantly lower in turbulent flow than in laminar flow. For example, if the surrounding air is colder than the rotor blade surface, a thermal pattern appears on the surface which indicates the state of the flow. Because the temperature on the turbulent flow region is colder than on the laminar low region, measuring this thermal pattern with a thermal imaging camera permits detecting the boundary layer condition in real-time.

Highly thermally sensitive high-speed infrared cameras with high performance telephoto lenses are used to visualize the boundary layer condition of rotor blades in operation, in which the rotor blades and the measurement position are several hundred meters apart. These measurements deliver qualitative information regarding the transition location along the rotor blades, and allow comparisons between different operational states and conditions.

A high-speed actively cooled high-end infrared camera ImageIR® 8300 with an InSb-focal-plane array photon detector in the format (640 x 512) IR pixels and with a thermal resolution better than 20 mK is used together with a telephoto lens of 200 mm to acquire high resolution thermal images of rotor blades in operation. Due to extremely short integration times, only minor motion blurs occur during tip speeds of 75 m/s.
